A collection of case studies using Activon® honey products

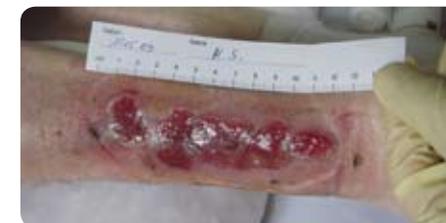
A 12x2cm shallow venous ulcer at the right shank of an 87 year old male.

At the time of the first application of honey the wound presented itself as a shallow, partially sloughy ulcer of approx. 12cm x 2cm in size (picture 1). The wound was cleaned with an octenidine solution. Algivon® was used as primary dressing and covered with an absorbent dressing. The dressing was changed thrice weekly.

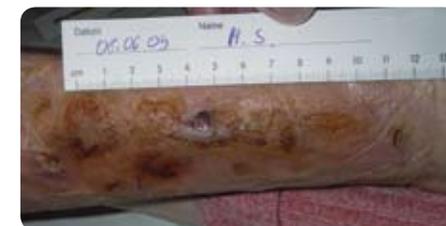
The same ulcer after 4 weeks of application of a honey-alginate dressing (Algivon®). Dressing changes were done thrice weekly.

Shortly after the application of the honey-alginate dressing and for the first time within weeks a granulation followed by epithelisation of the wound bed, started. Within a period of only 4 weeks the ulcer size decreased to approx. 0.5cm x 0.5cm (picture 2).
